**Building Preservation Guidelines  
Historic Preservation Commission  
City of New Richmond**

**Volume I  
Buildings 1-14**

July 2000

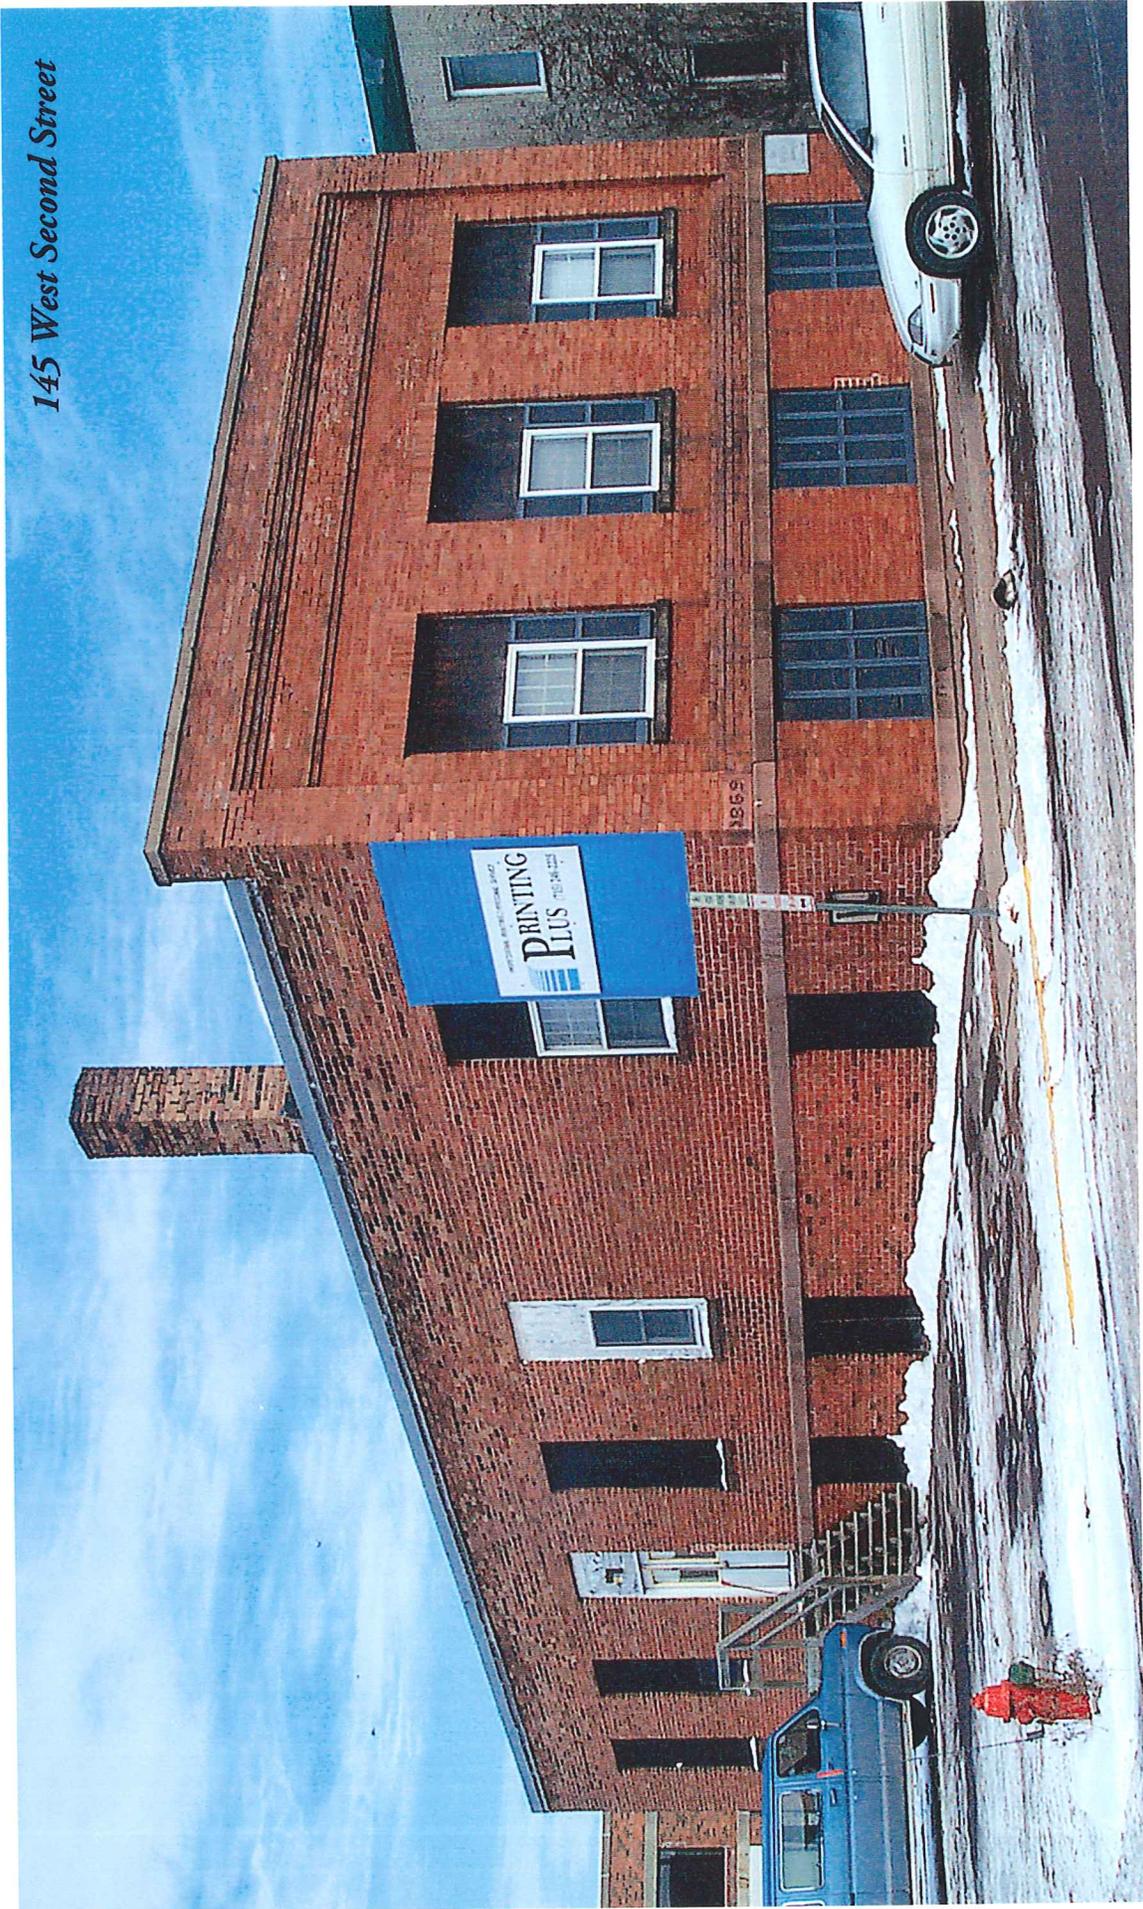
145 West Second Street

- A. *Entire exterior:* There is minor masonry repair/tuck pointing to be done on the facade of the building
- B. *Parapet Wall:* Apparently there was once a portion of the parapet in the middle of the south elevation, which was raised above the present parapet cap. Restoration

A. *South elevation:* Undoubtedly the building at one time had awnings at the upper level which would have been simple, one piece retractable earth toned canvas. Replacement of these would be desirable.

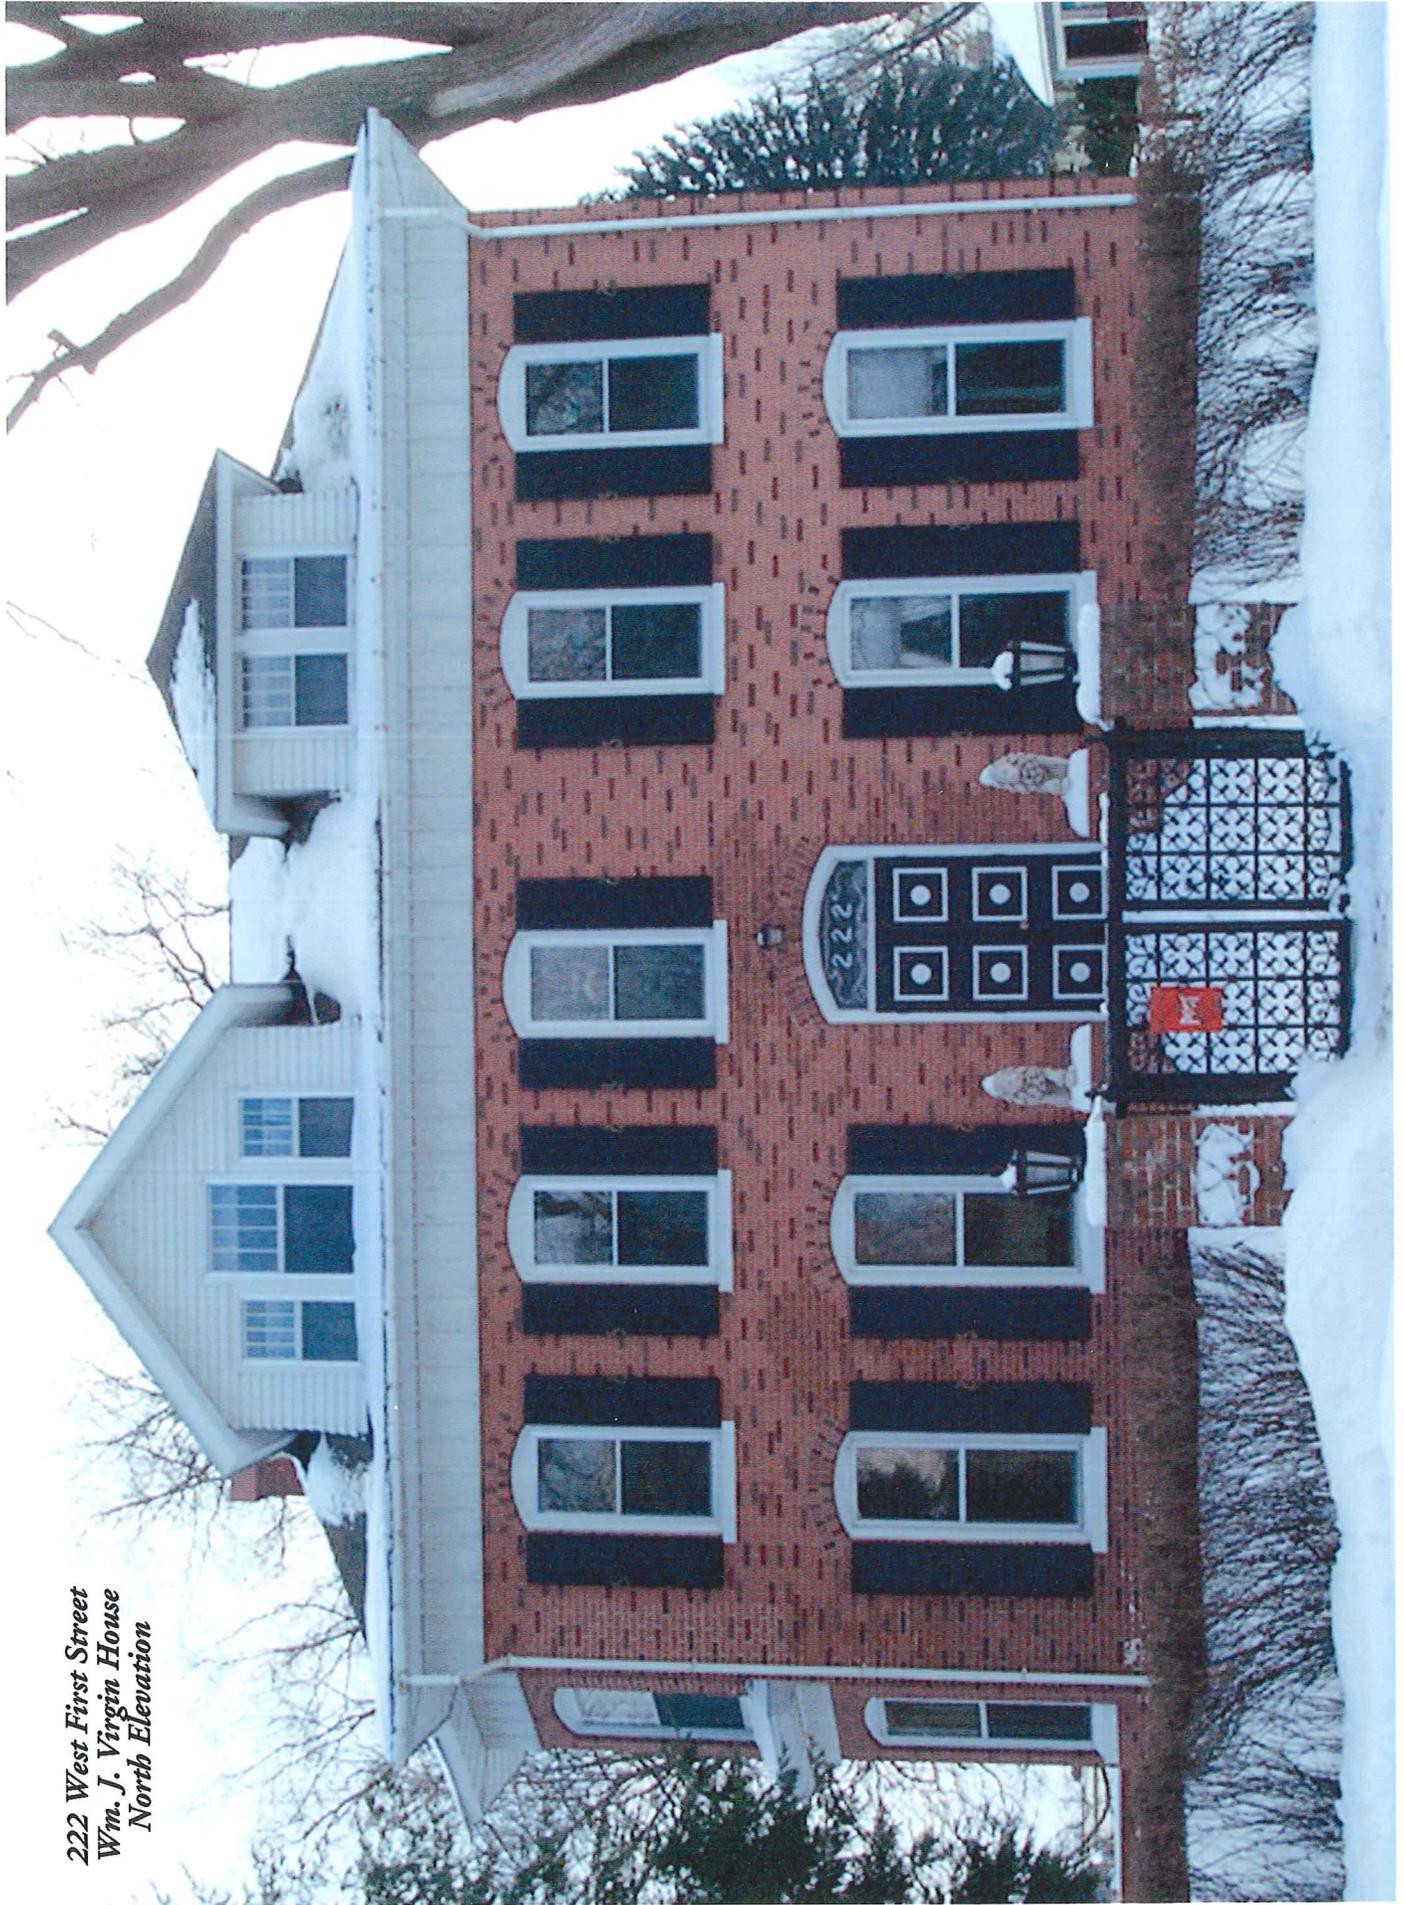
222 West First Street  
Wm. J. Virgin House  
North Elevation

A. The north facade of this house would benefit from some foundation plantings.

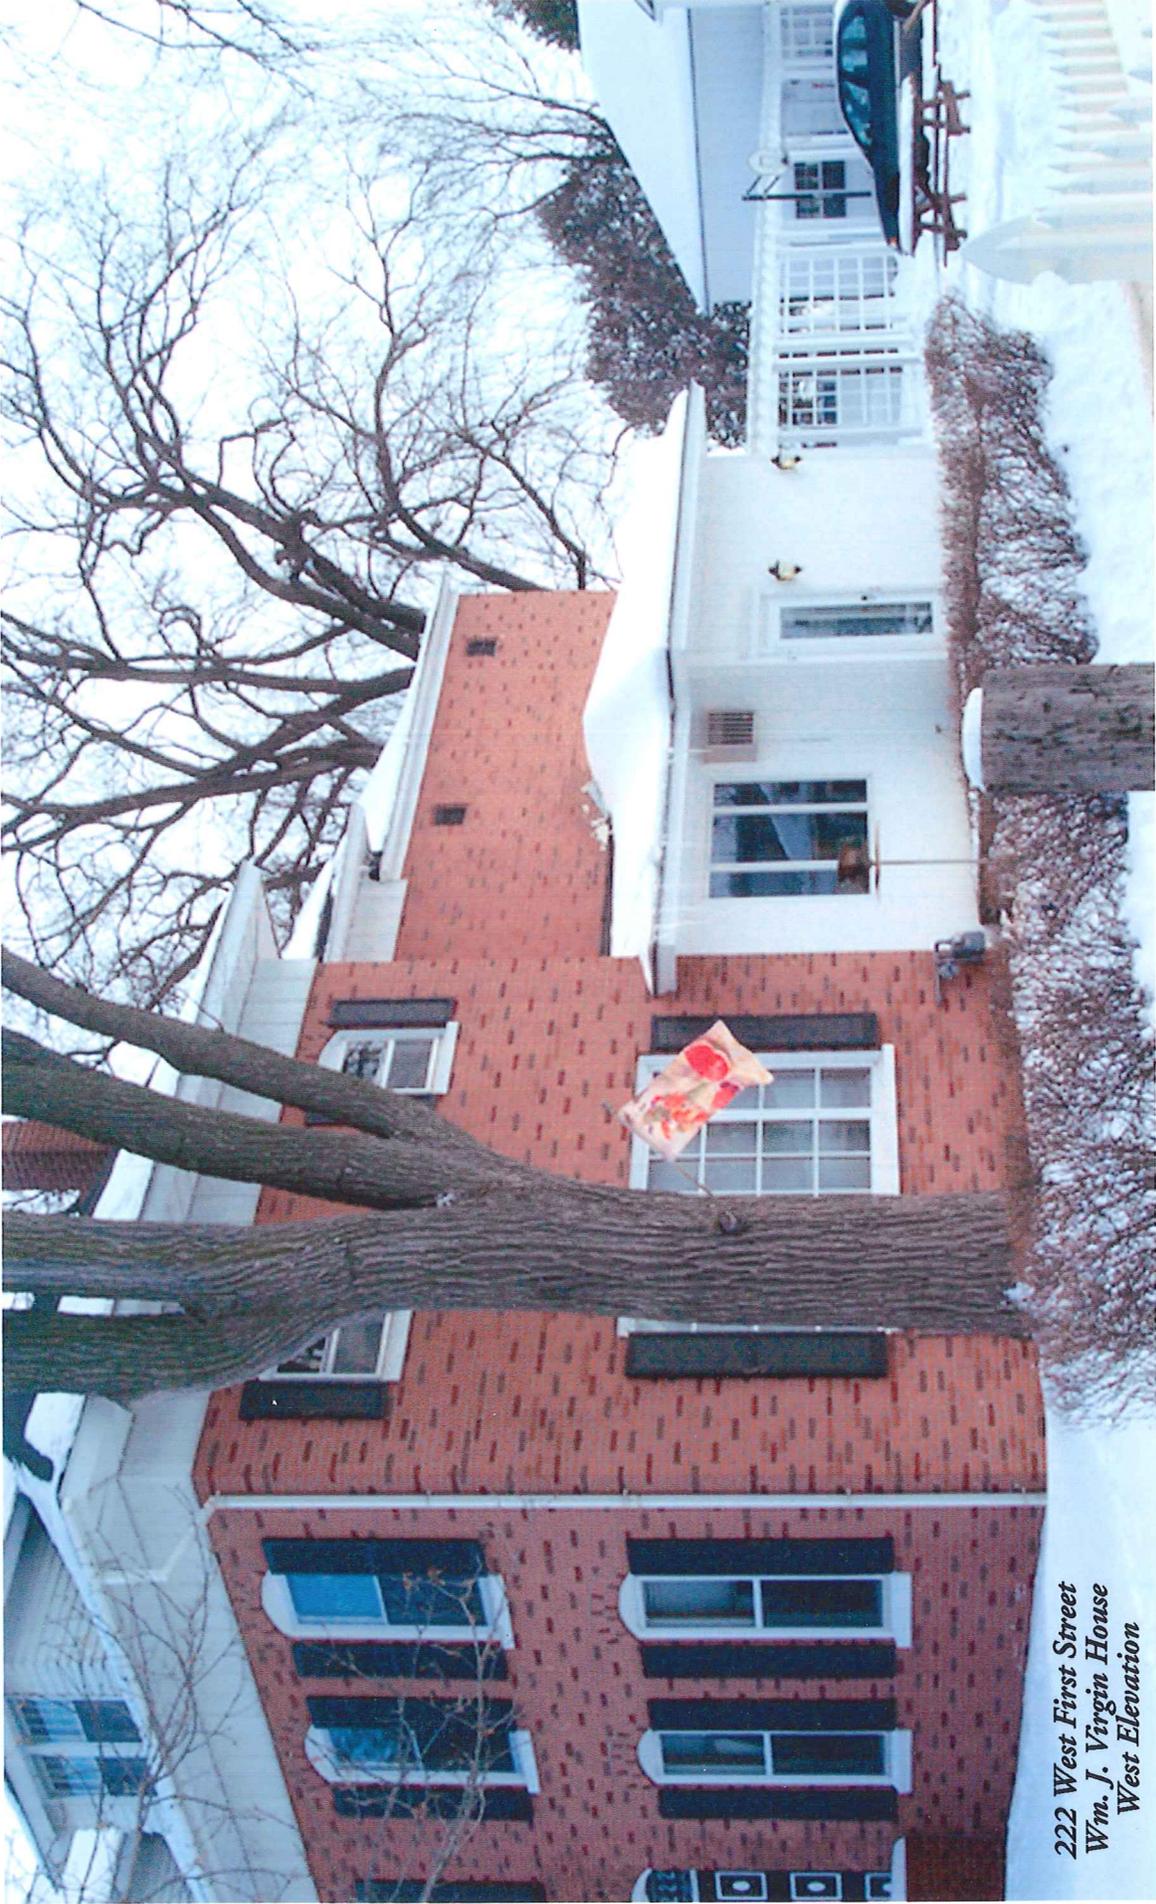
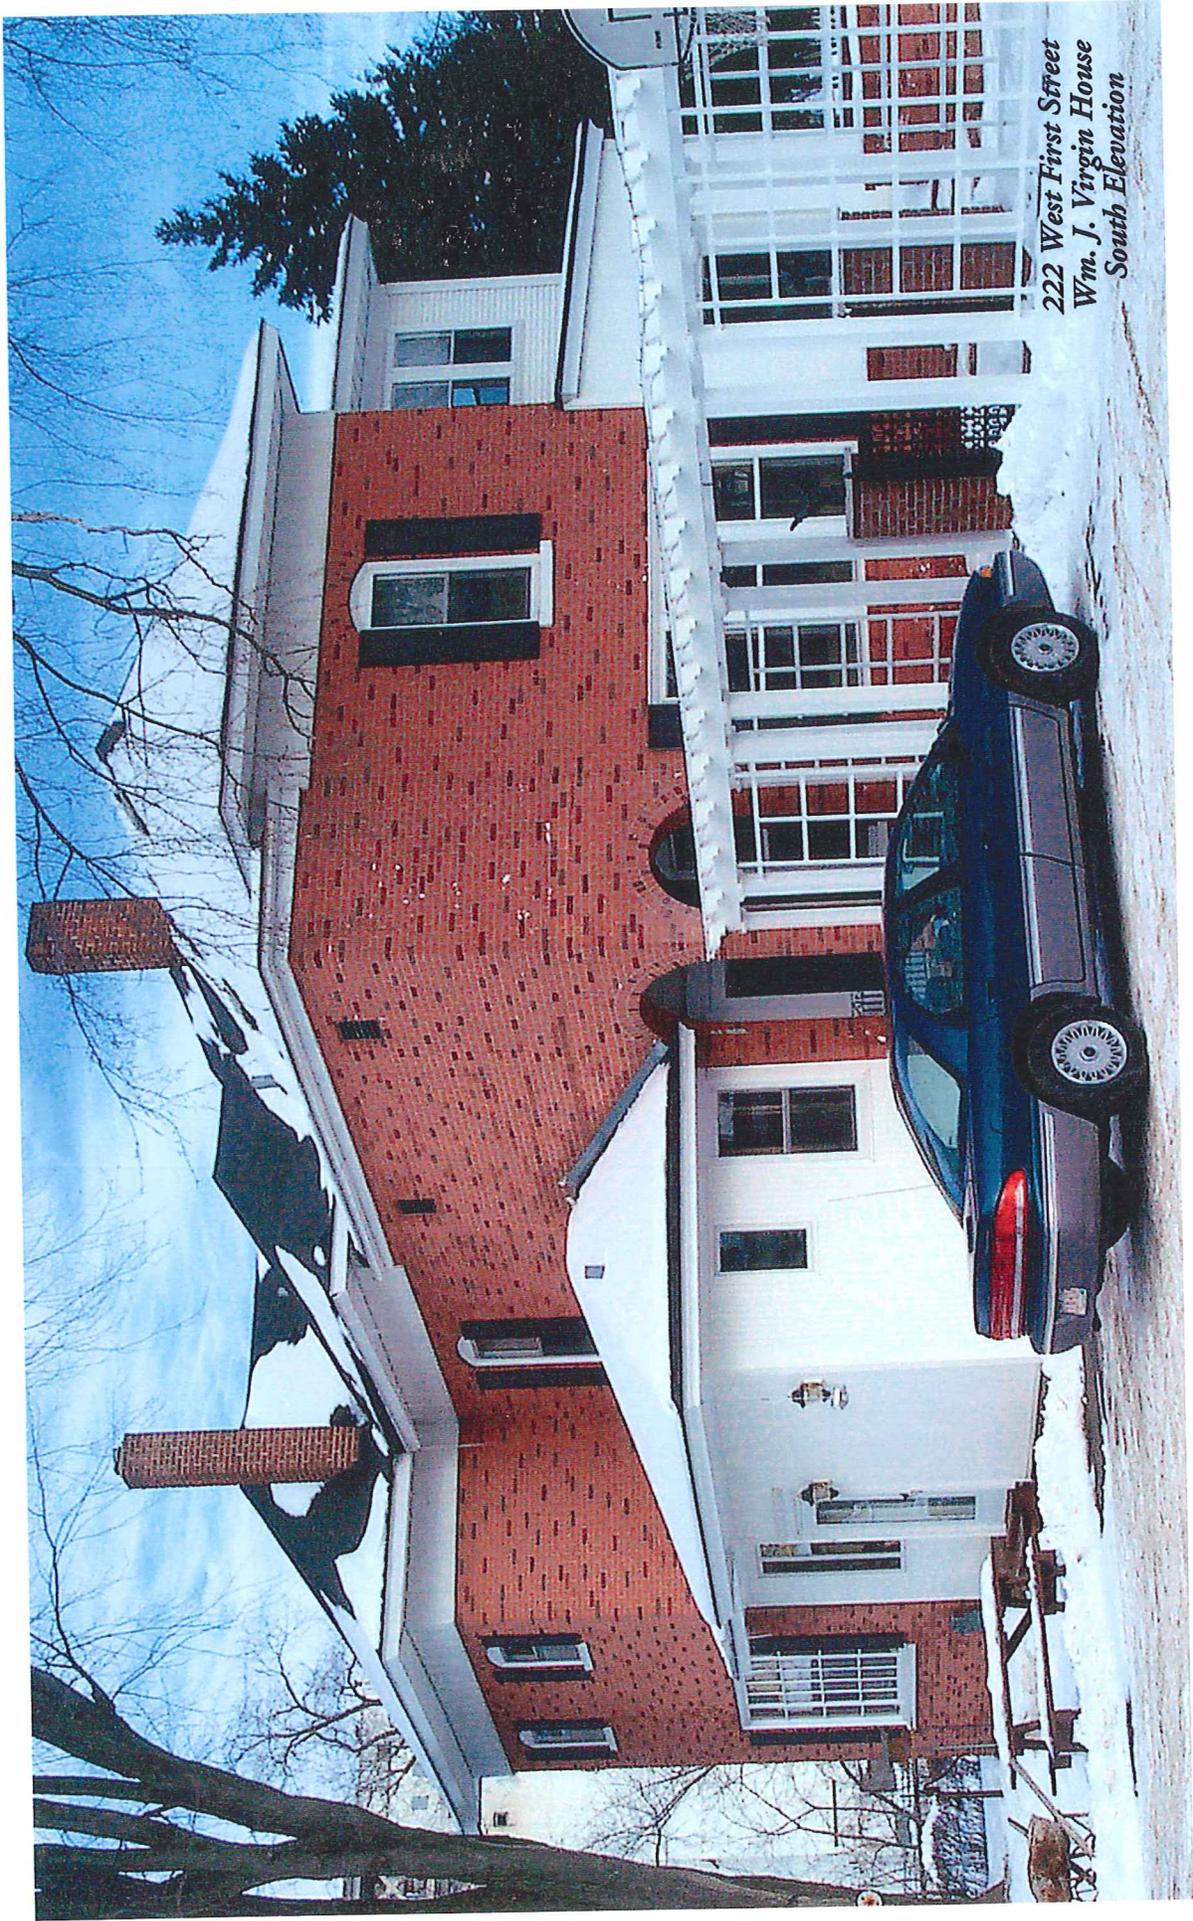
222 West First Street  
Wm. J. Virgin House  
West Elevation

A. Detailing problems relate to these arches come from enclosing a two story porch, formerly open. Enclosing it in brick gives it far more solidity than it deserves. In the event this bricked in porch is ever rebuilt some alternate articulation should be sought. It is possible that a wood facing with a modicum of windows would be more appropriate. A two story wood face should have a more comfortable intersection of the present wood room to the west and the wood trellis to the south and most importantly would eliminate the unbalanced south facade above and the uncomfortable joint in the west wall of the house.

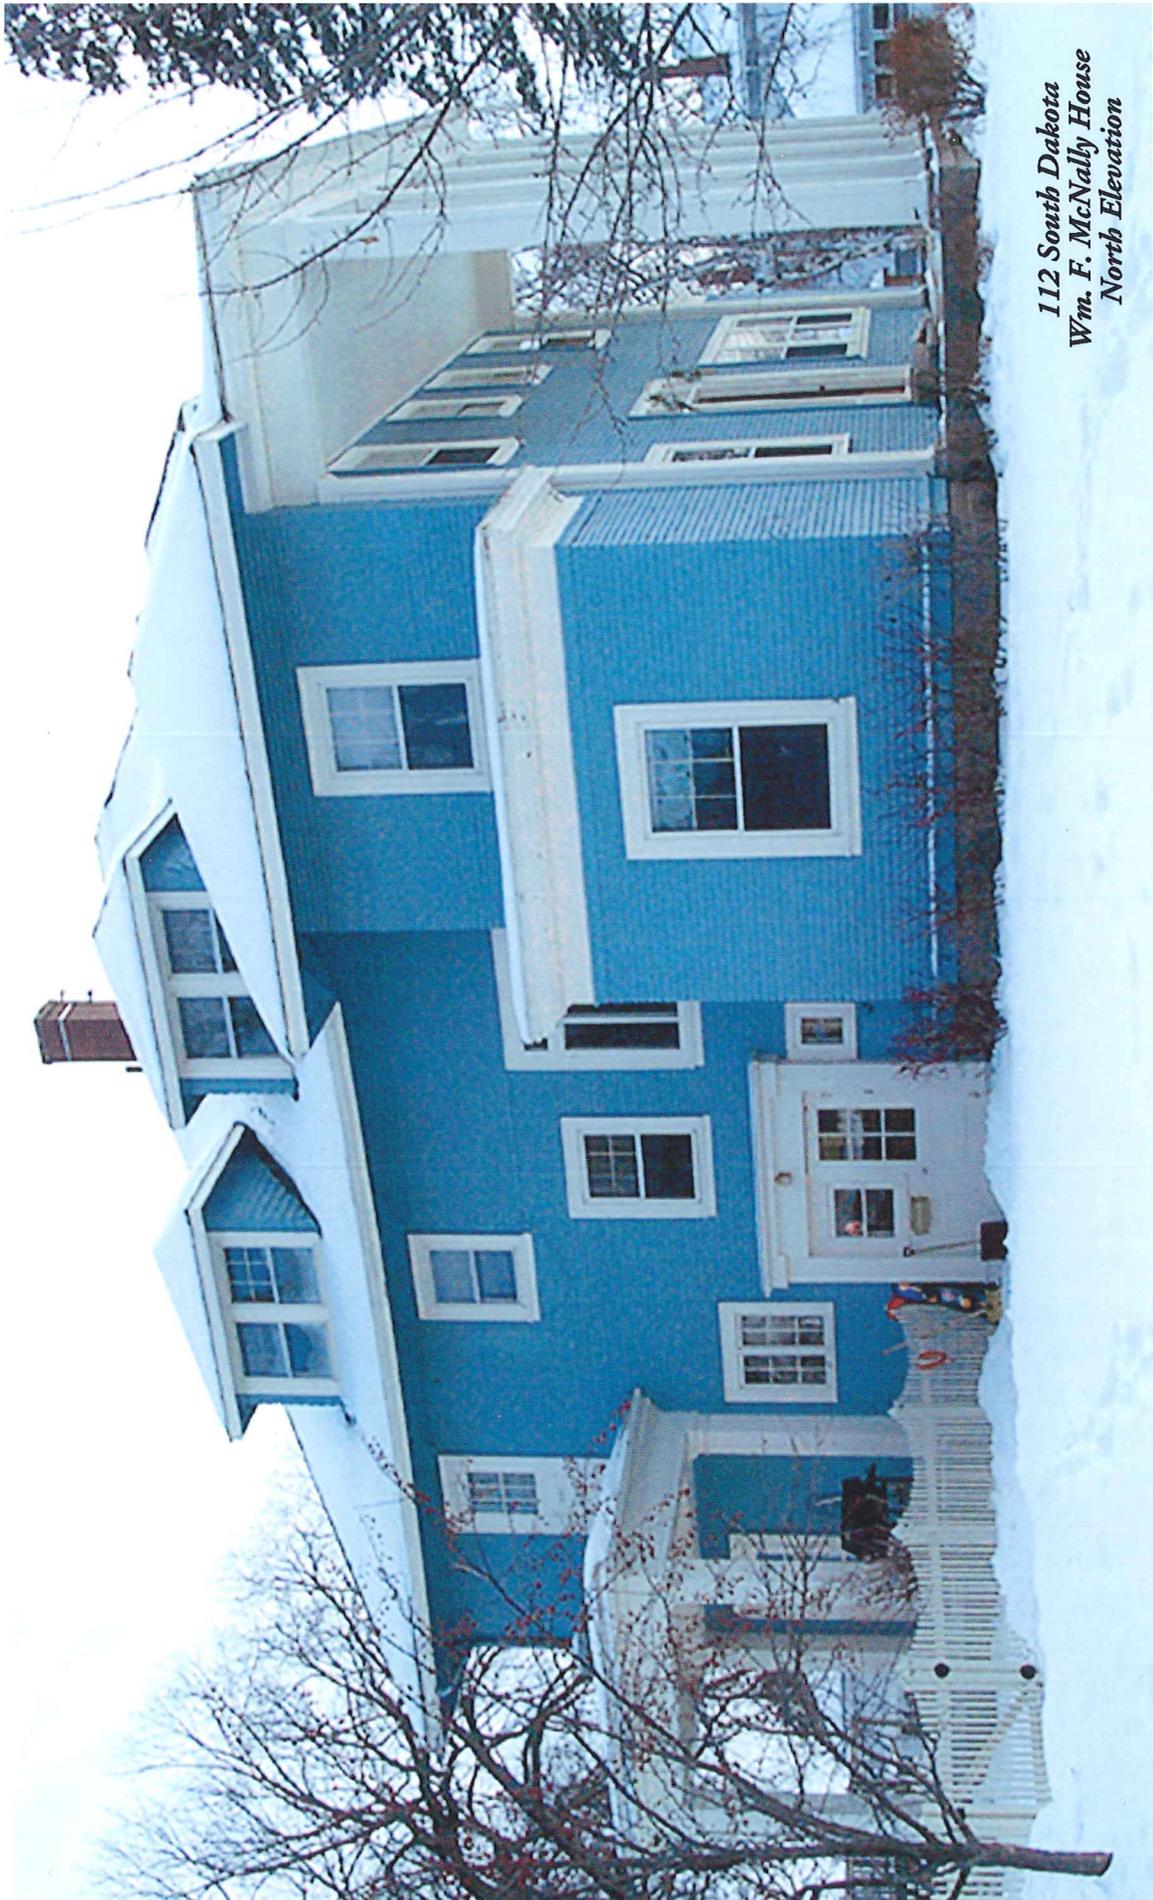
*112 South Dakota  
Wm. F. McNally House  
North Elevation*

1. **Grade level entrance:** Has lost some of its fine detailing, it could be restored as per the historic photographs.
2. **Windows:** The window above the grade level entrance has been unsympathetically modified.
3. **Railings:** If returned to the porch and projected room on the west end of the elevation, they would add continuity to the facade and would hide the inappropriately placed air conditioning unit on the porch roof.
4. **Open porch:** This was once an enclosed space. Consideration should be given to again enclosing it to return the original balance to the north facade.

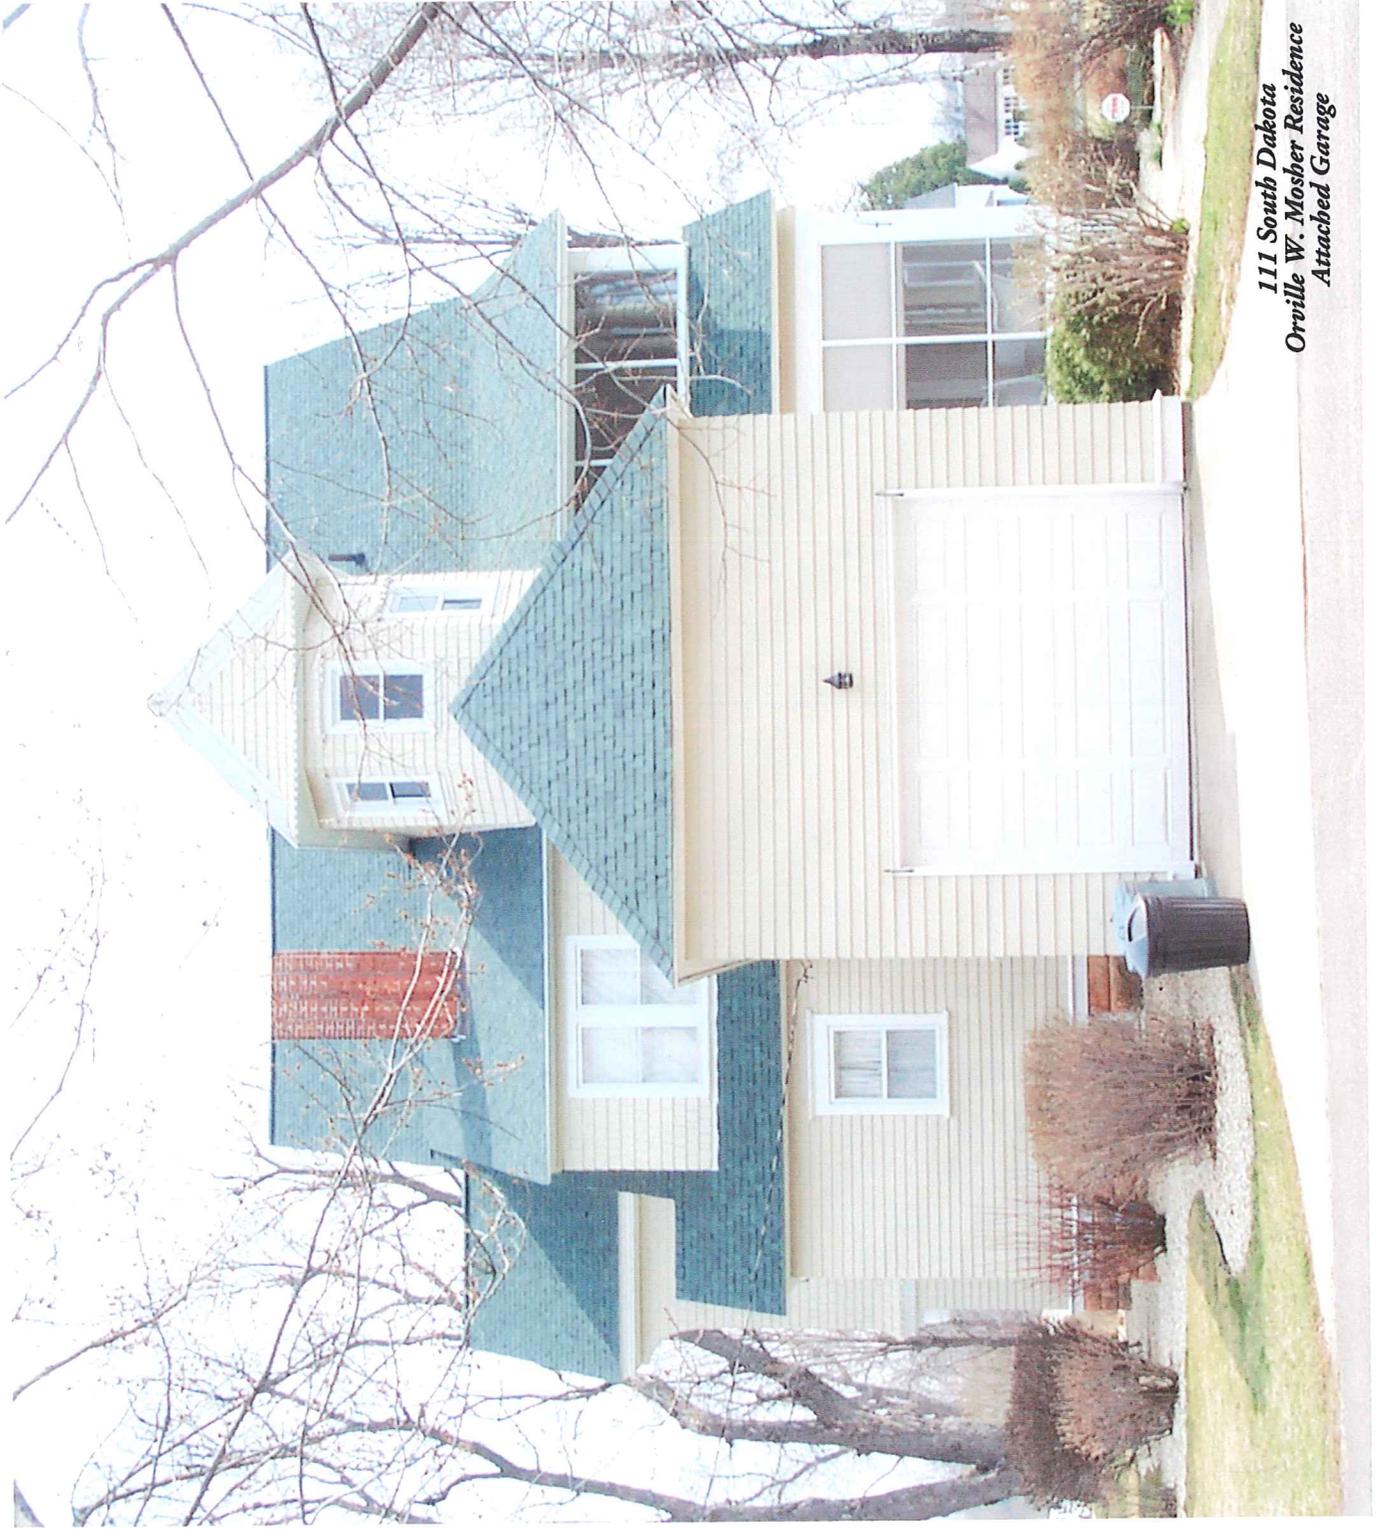
*111 South Dakota  
Orville W. Mosher Residence  
Attached Garage*

The largest modification made to the house is the addition of an attached garage. There are no examples in the 70 or so houses Gilbert designed of an attached garage. Where carriage houses were attached to houses in the 19th century, they were designed to incorporate details consistent with the house, or which might be found in detached carriage houses. Therefore:

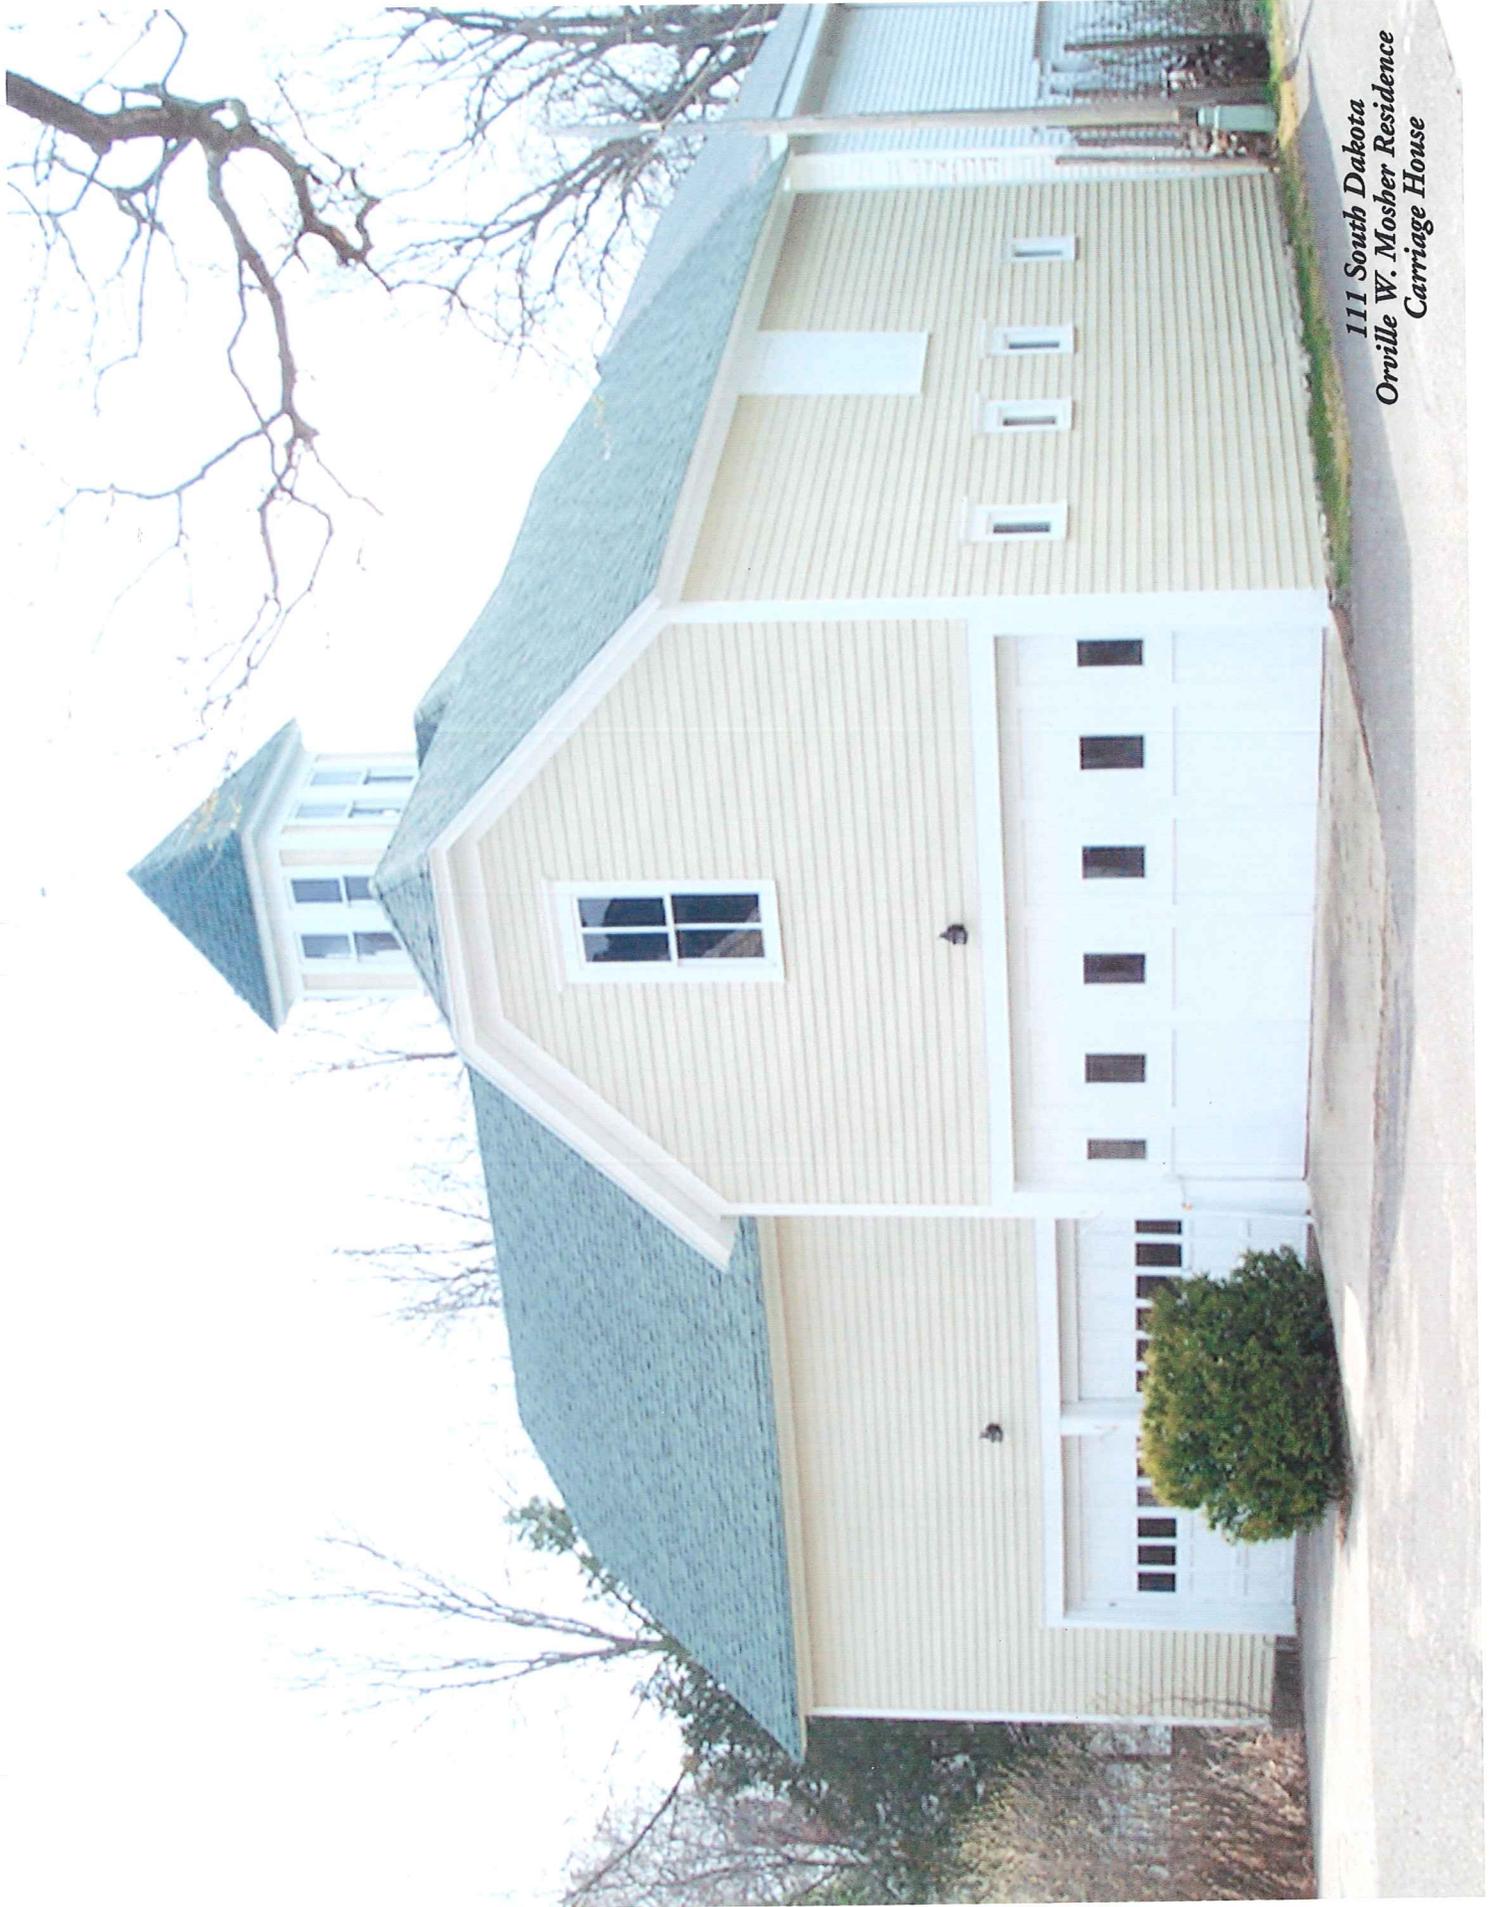
*111 South Dakota  
Orville W. Mosher Residence  
Carriage House*

A. The overhead doors in the east section of the carriage house are not original. In the event they are replaced there are overhead doors that present a more sympathetic exterior design.

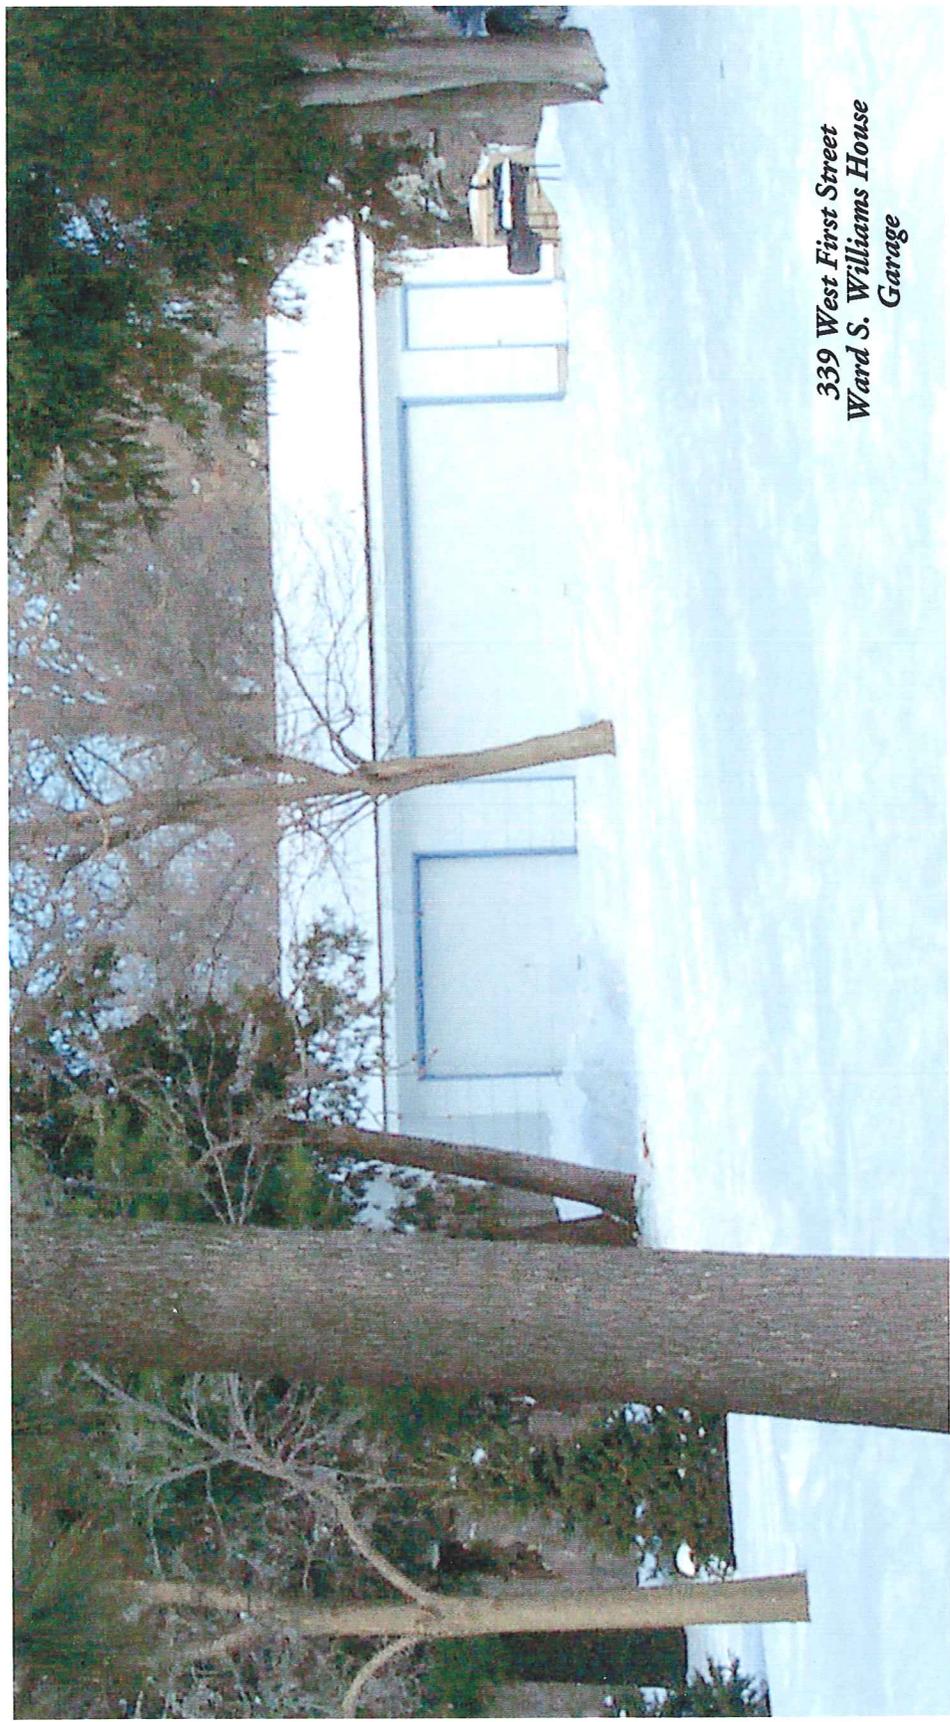
*339 West First Street  
Ward S. Williams House  
Garage*

The garage, while sited rather well, is quite obvious. The colored trim accent, otherwise uninteresting, around the doors which would be best left white.

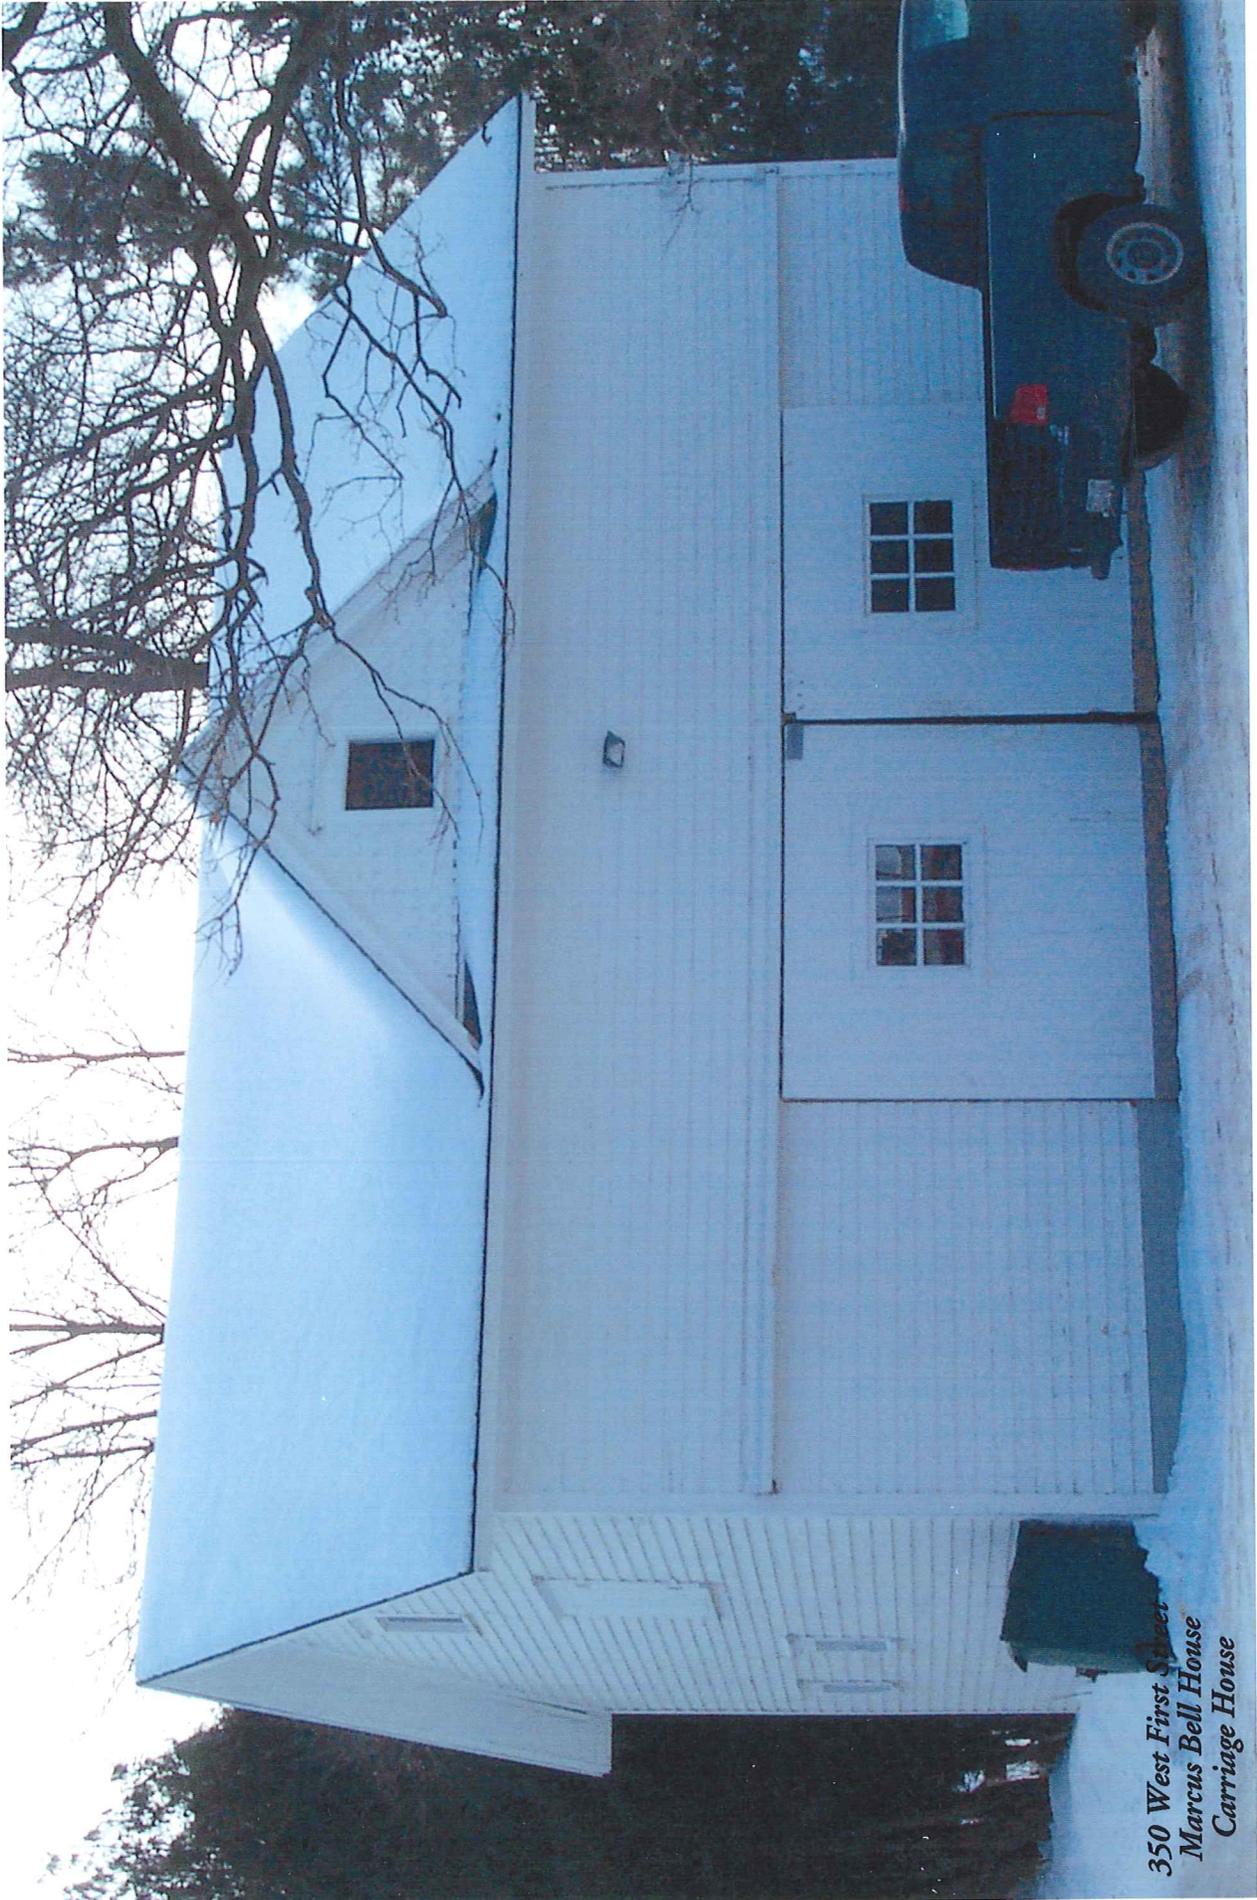
350 West First Street  
Marcus Bell House  
Carriage House

A. The carriage house is intact and should be preserved as it is.
