**Building Preservation Guidelines  
Historic Preservation Commission  
City of New Richmond**

**Volume I  
Buildings 1-14**

July 2000

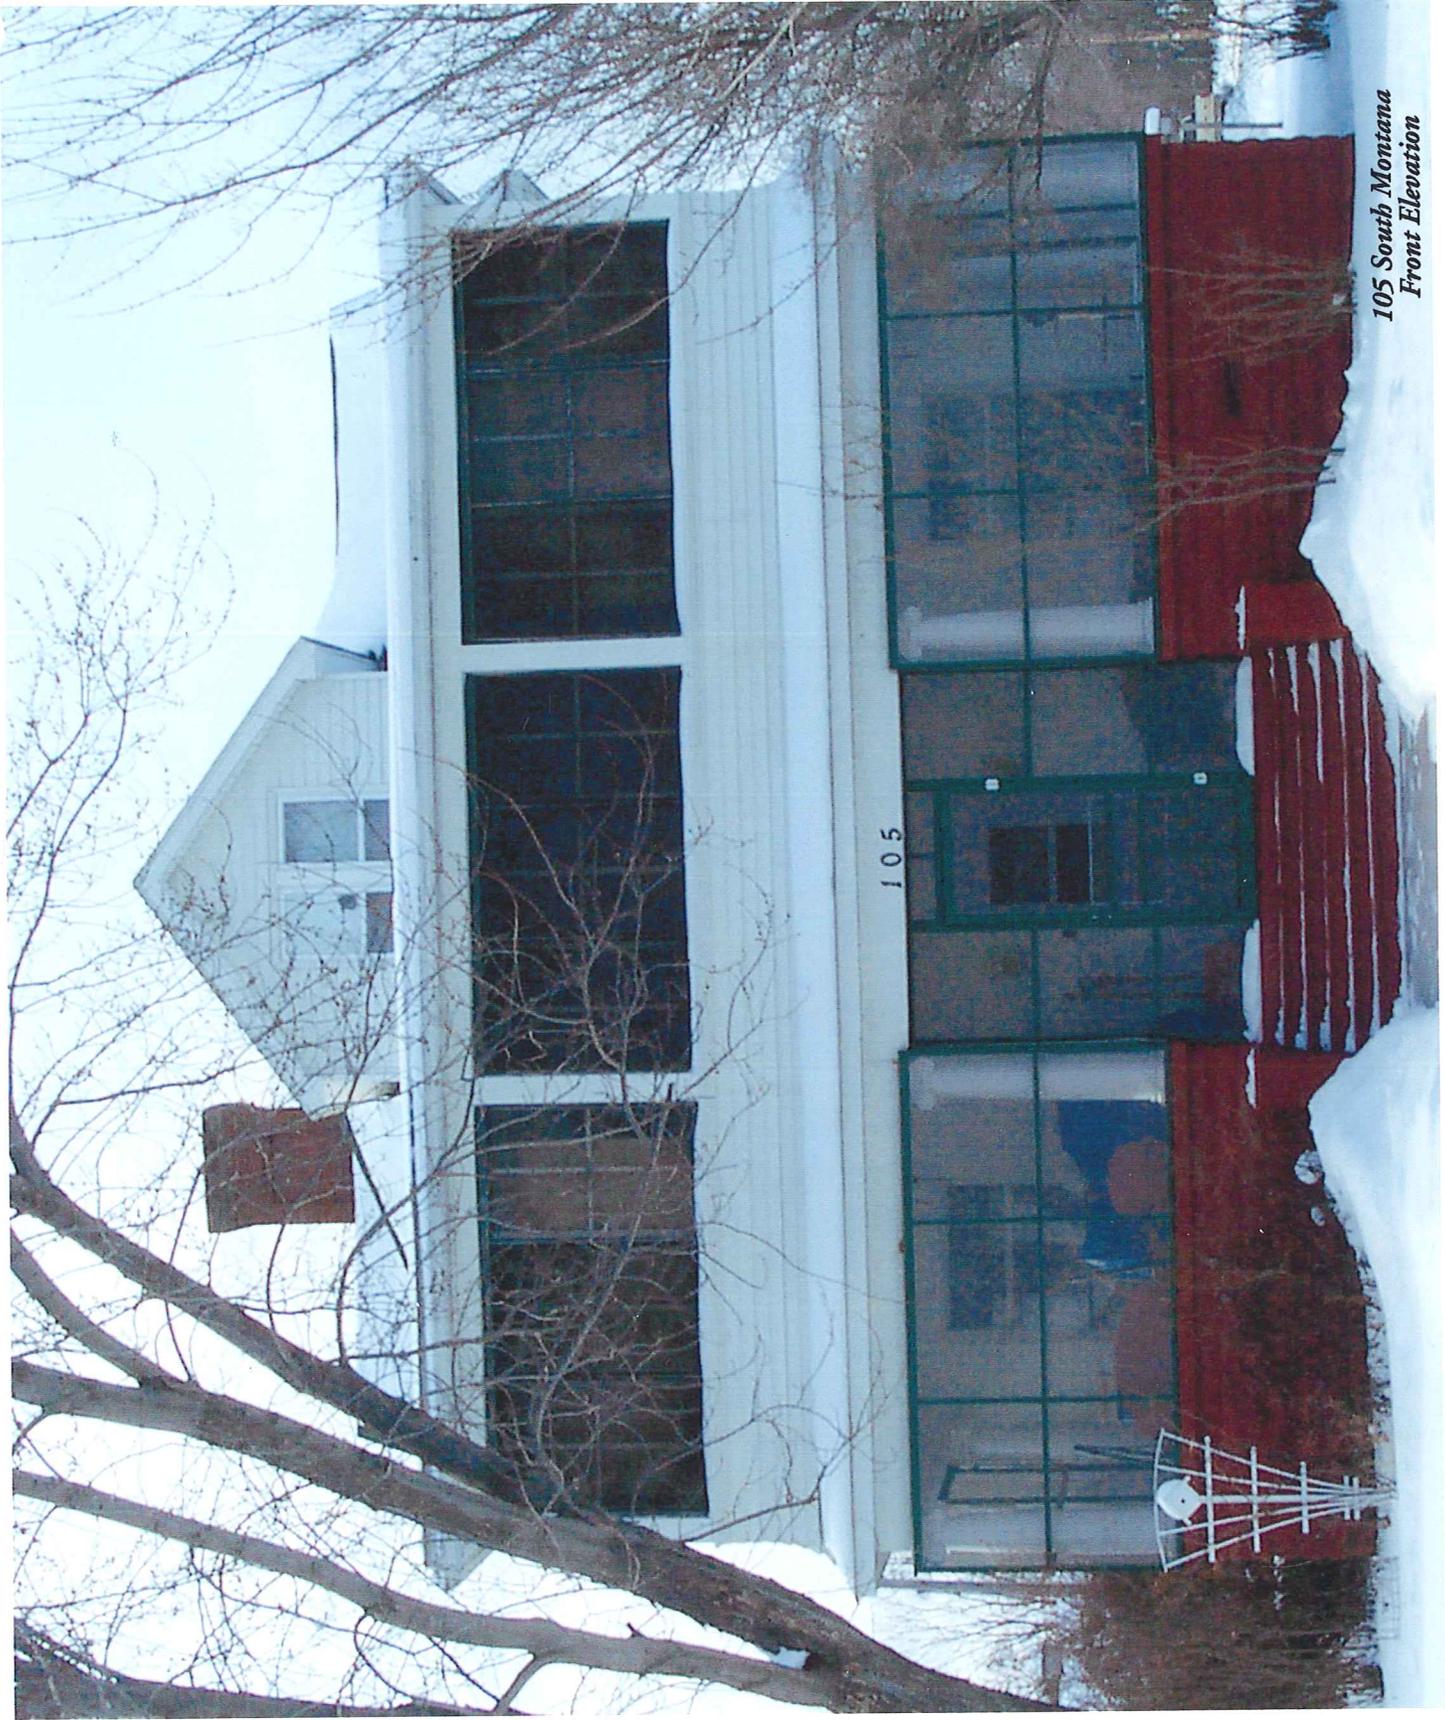
105 South Montana  
Front Elevation

- A. The red color of the foundation is unsympathetic to the masonry material of which it is comprised. This could be removed using a biodegradable stripping agent and then block sealed with a clear masonry sealant. An alternative treatment would be to paint the foundation a concrete masonry color.
