**Building Preservation Guidelines  
Historic Preservation Commission  
City of New Richmond**

**Volume I  
Buildings 1-14**

July 2000

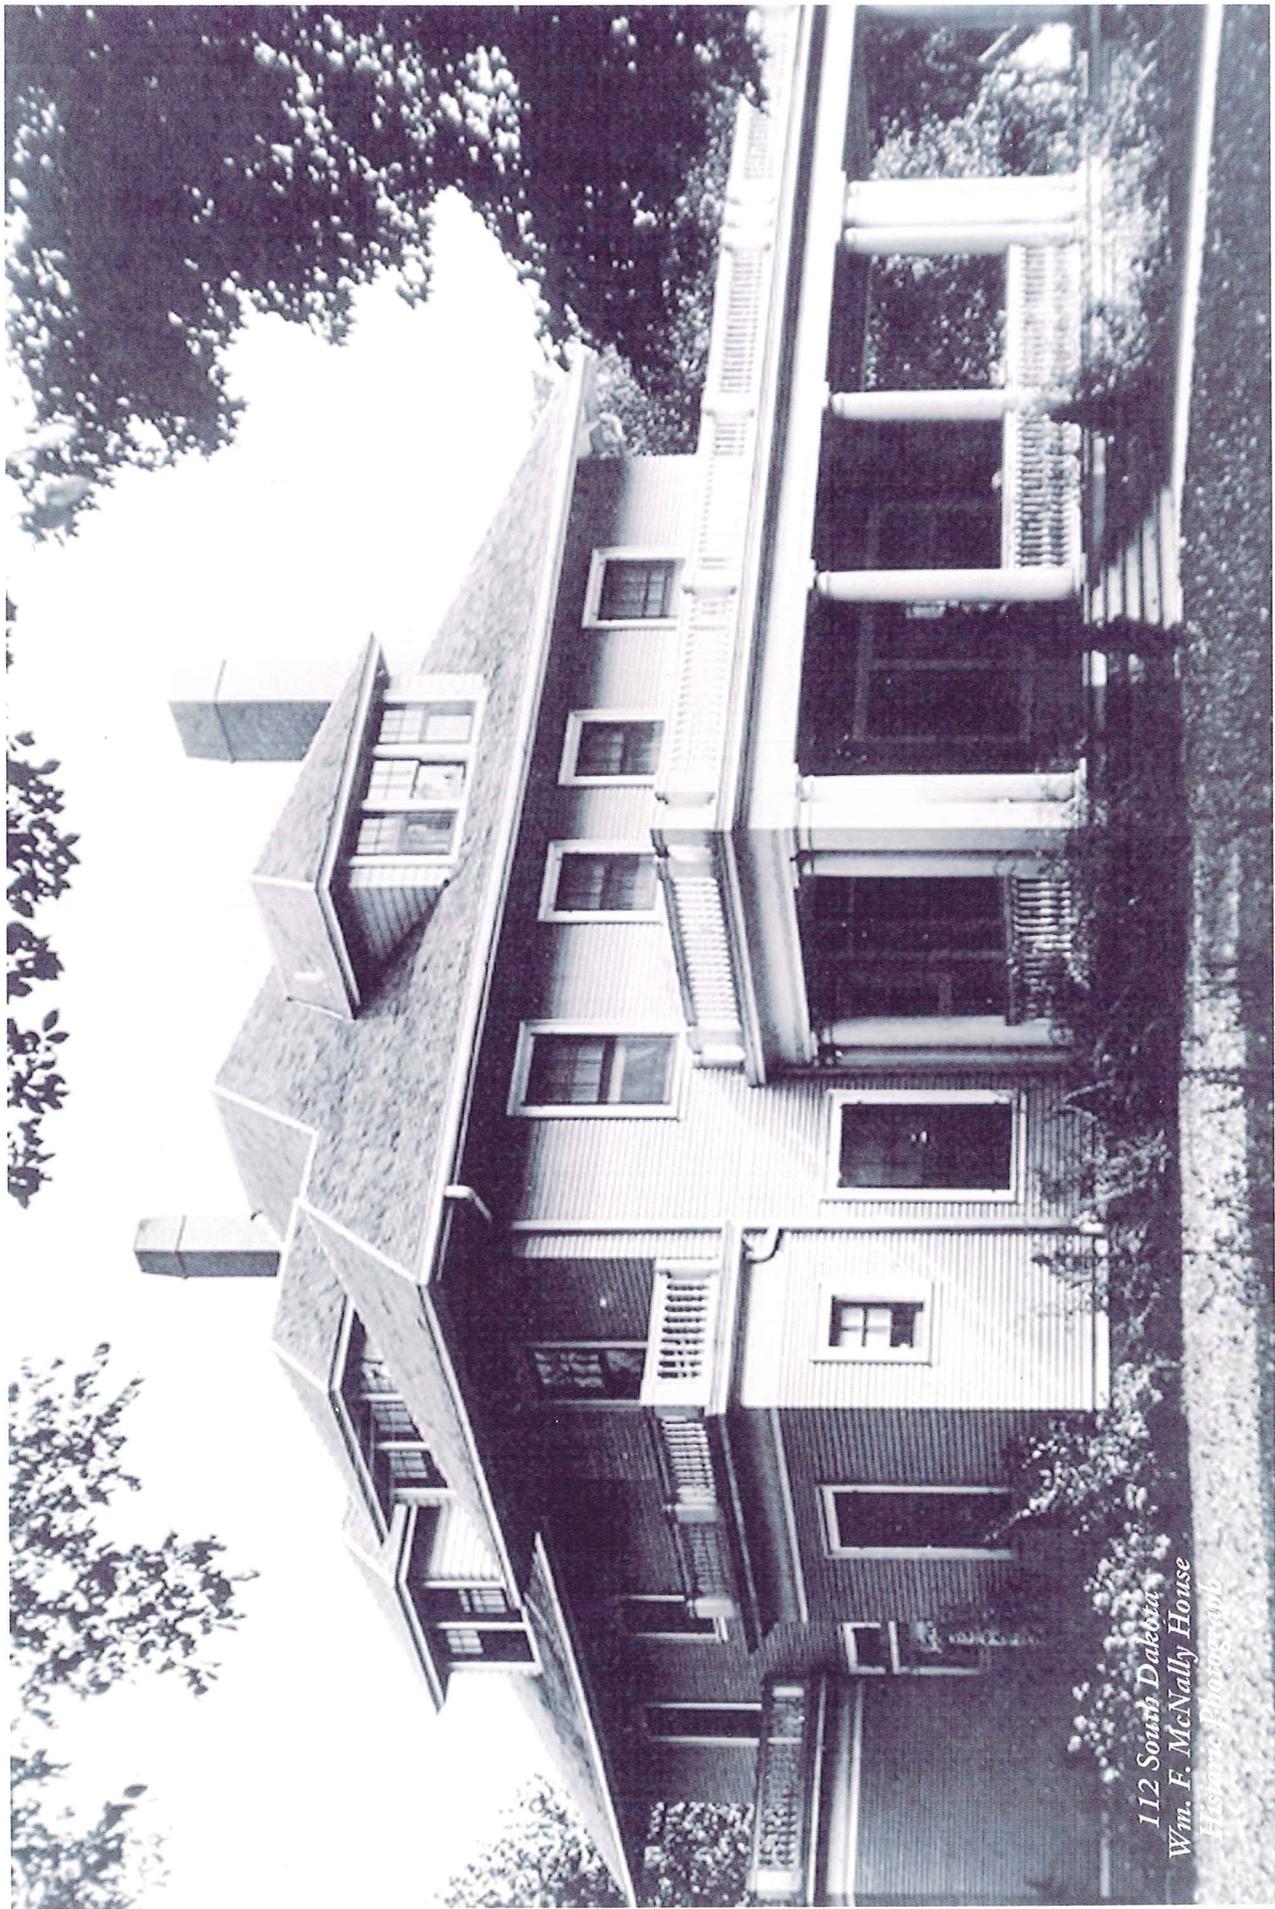
112 Sioux Dakota  
Wm. F. McNally House  
Historic Photograph

1. **Porch:** The present two story "ante-bellum" Colonial porch contributes little to the livability of the house and is really inappropriate to the design of the remainder of the house. Historic photos reveal the magnificent strength of the original west elevation. The porch was shifted to the south to allow a porte cochere at the south end of the porch. While recreating this drive through would yield a delightful access to the house

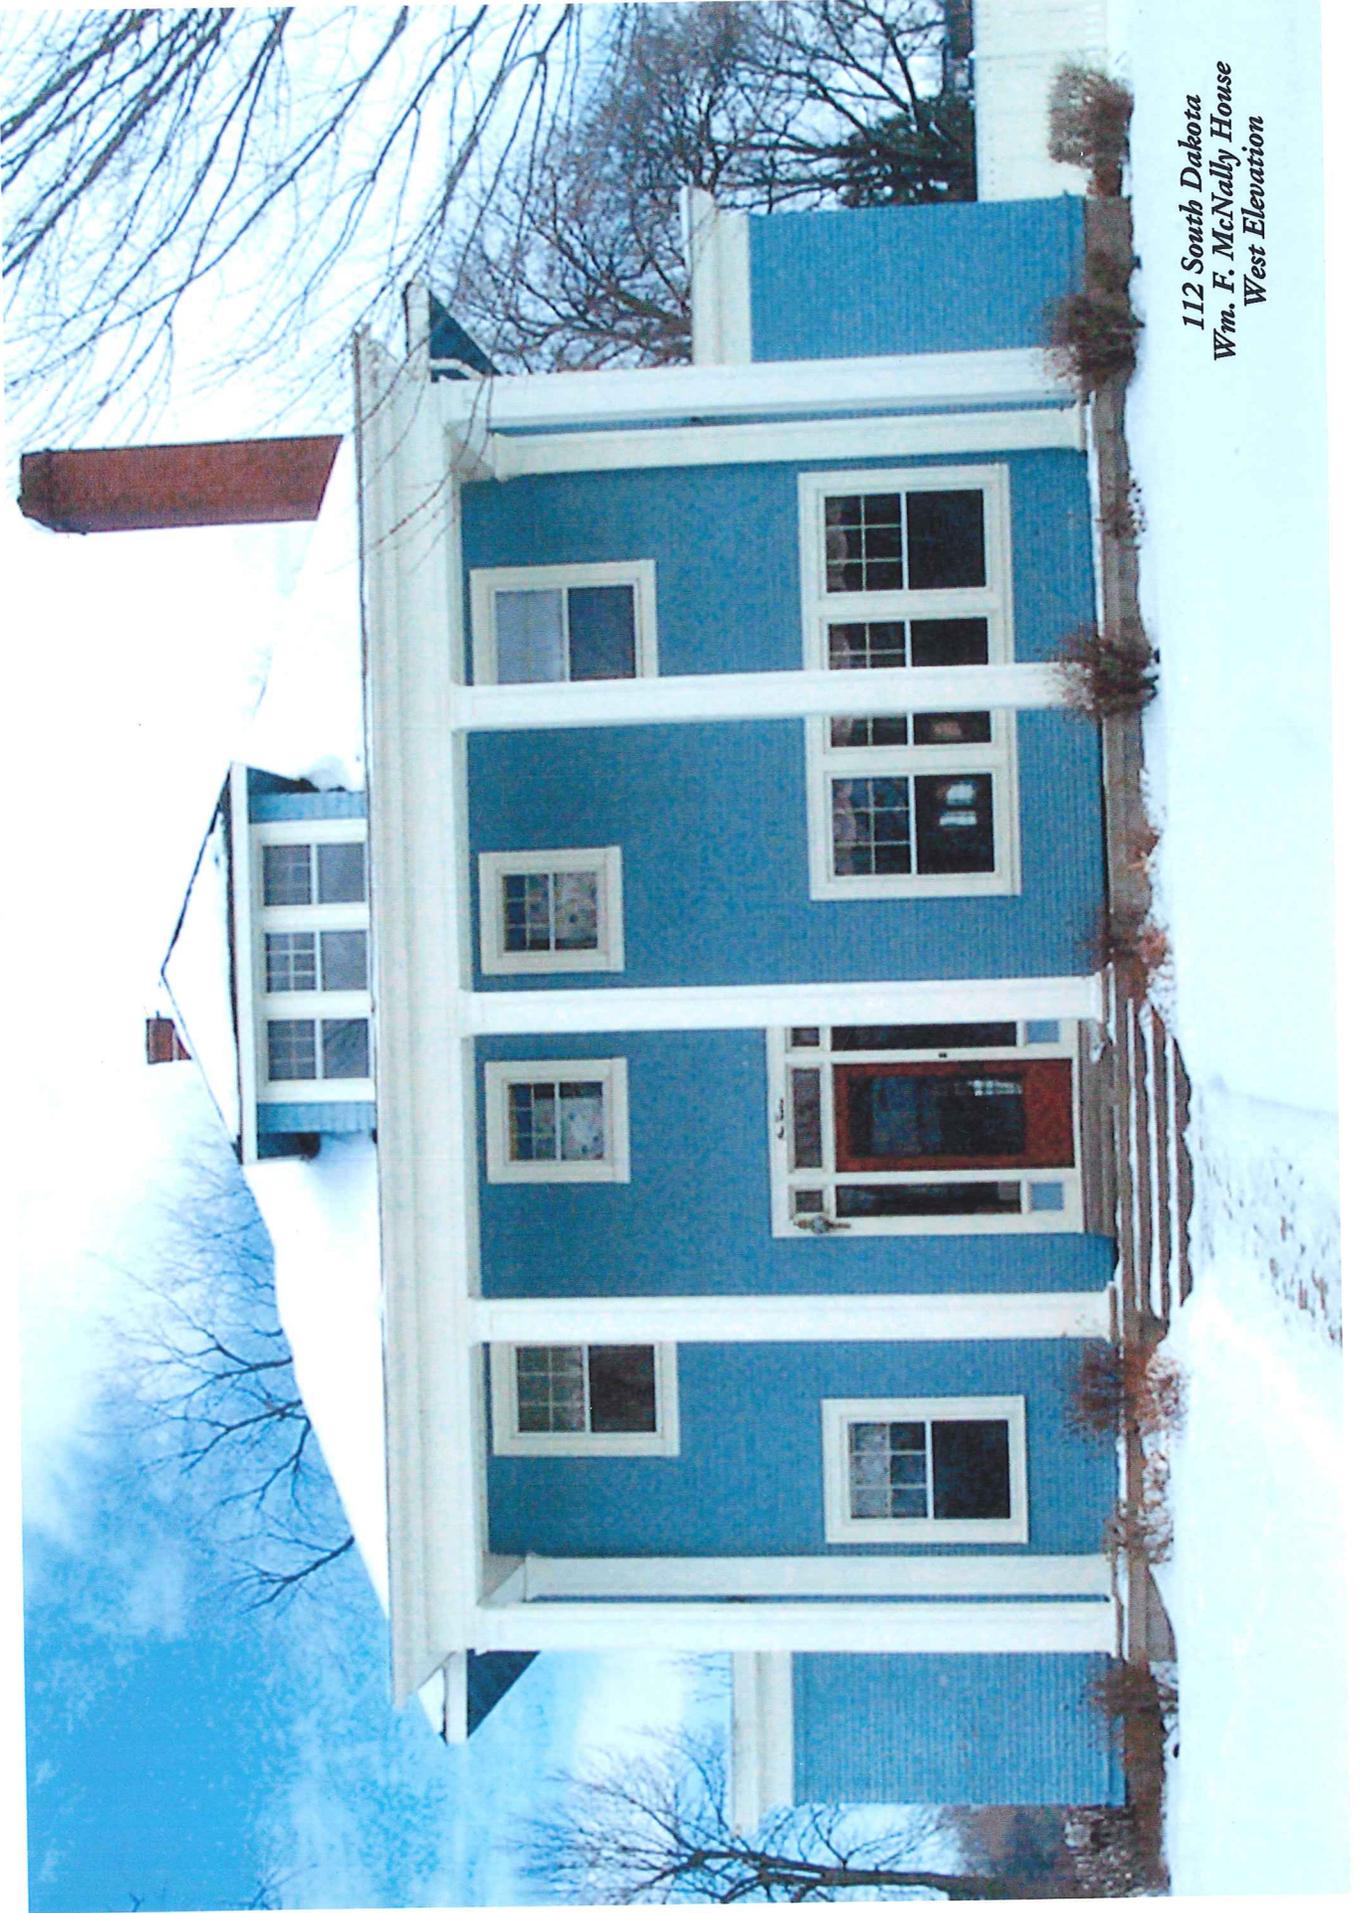
*112 South Dakota  
Wm. F. McNally House  
West Elevation*

and a well hidden convenient auto parking place, it is also possible that the last bay of the porch might be rebuilt as an extension of the porch.

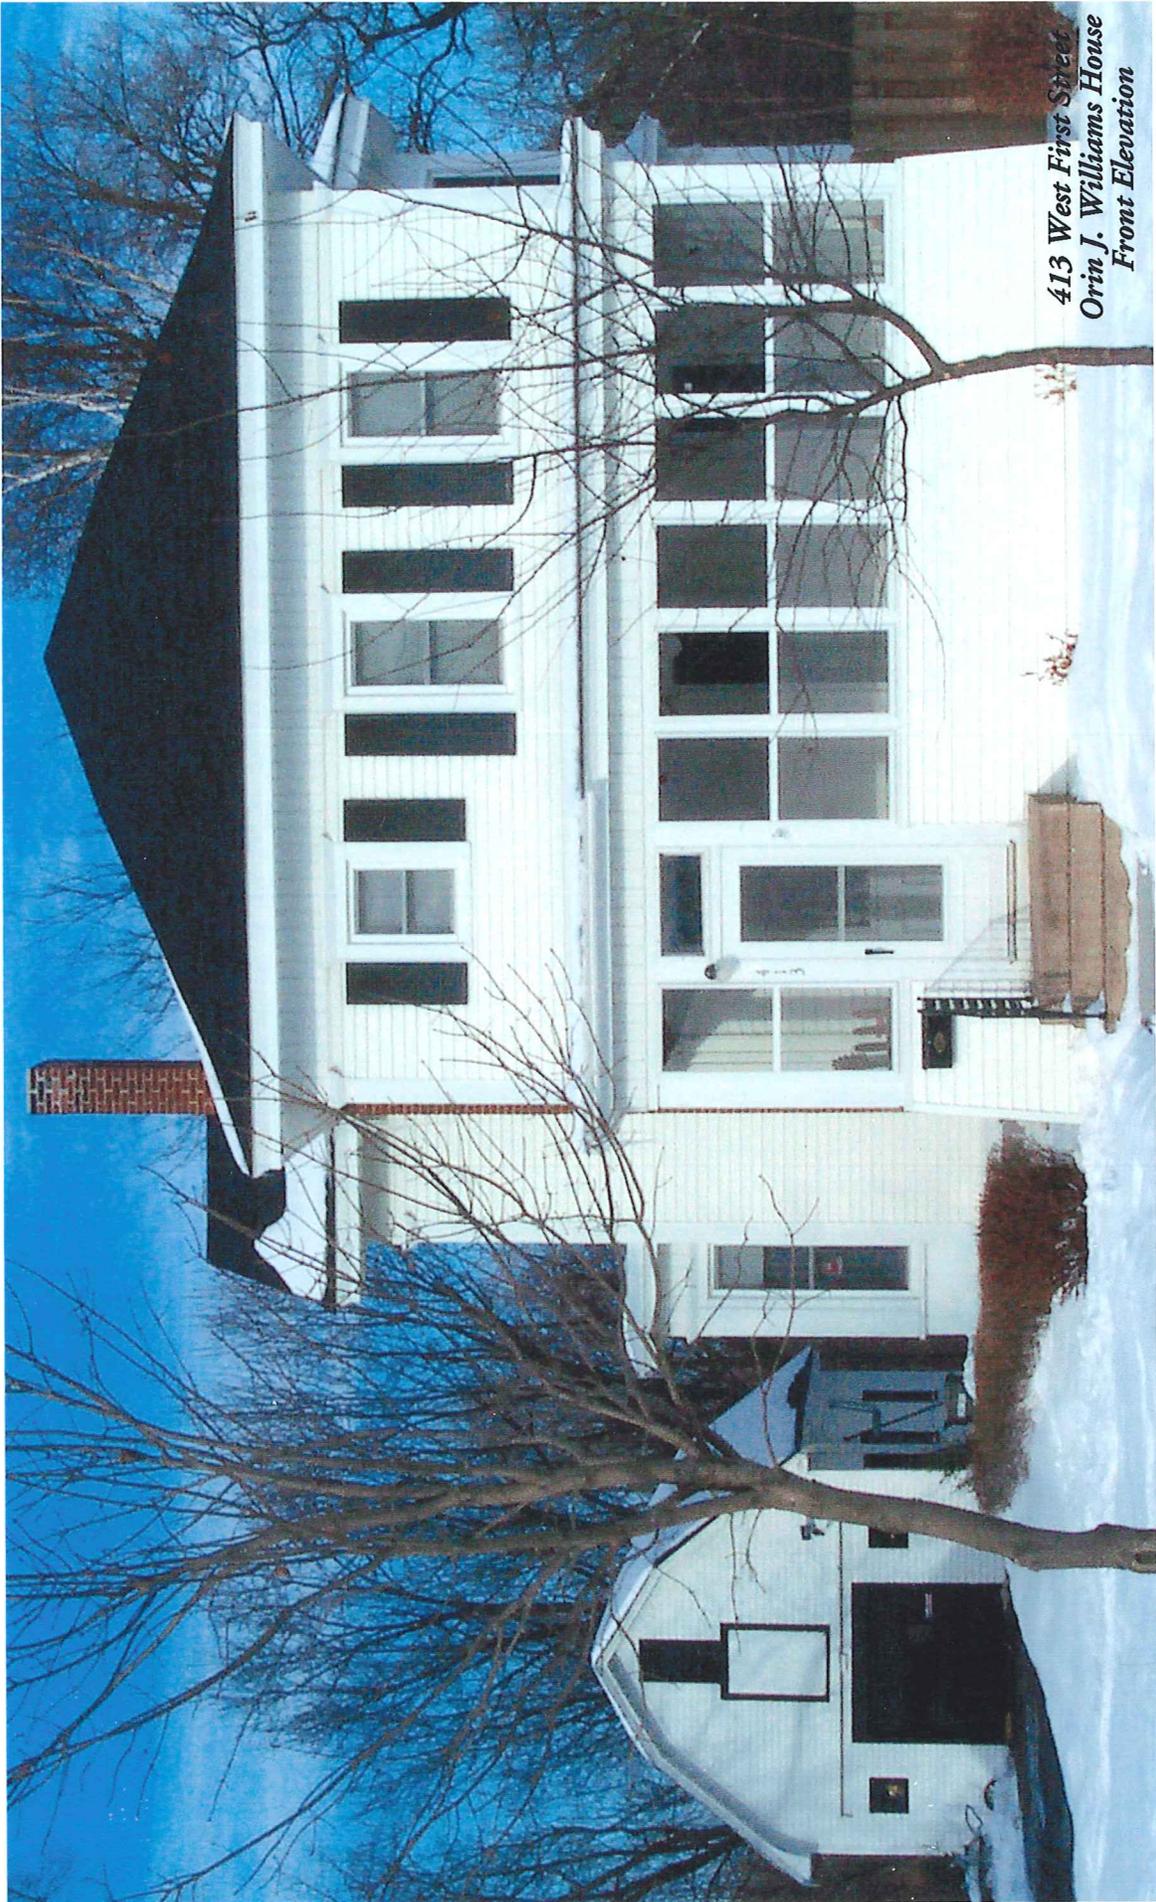
*413 West First Street  
Orin J. Williams House  
Front Elevation*

The existing siding under the metal is probably original and its detail will reveal the original design.

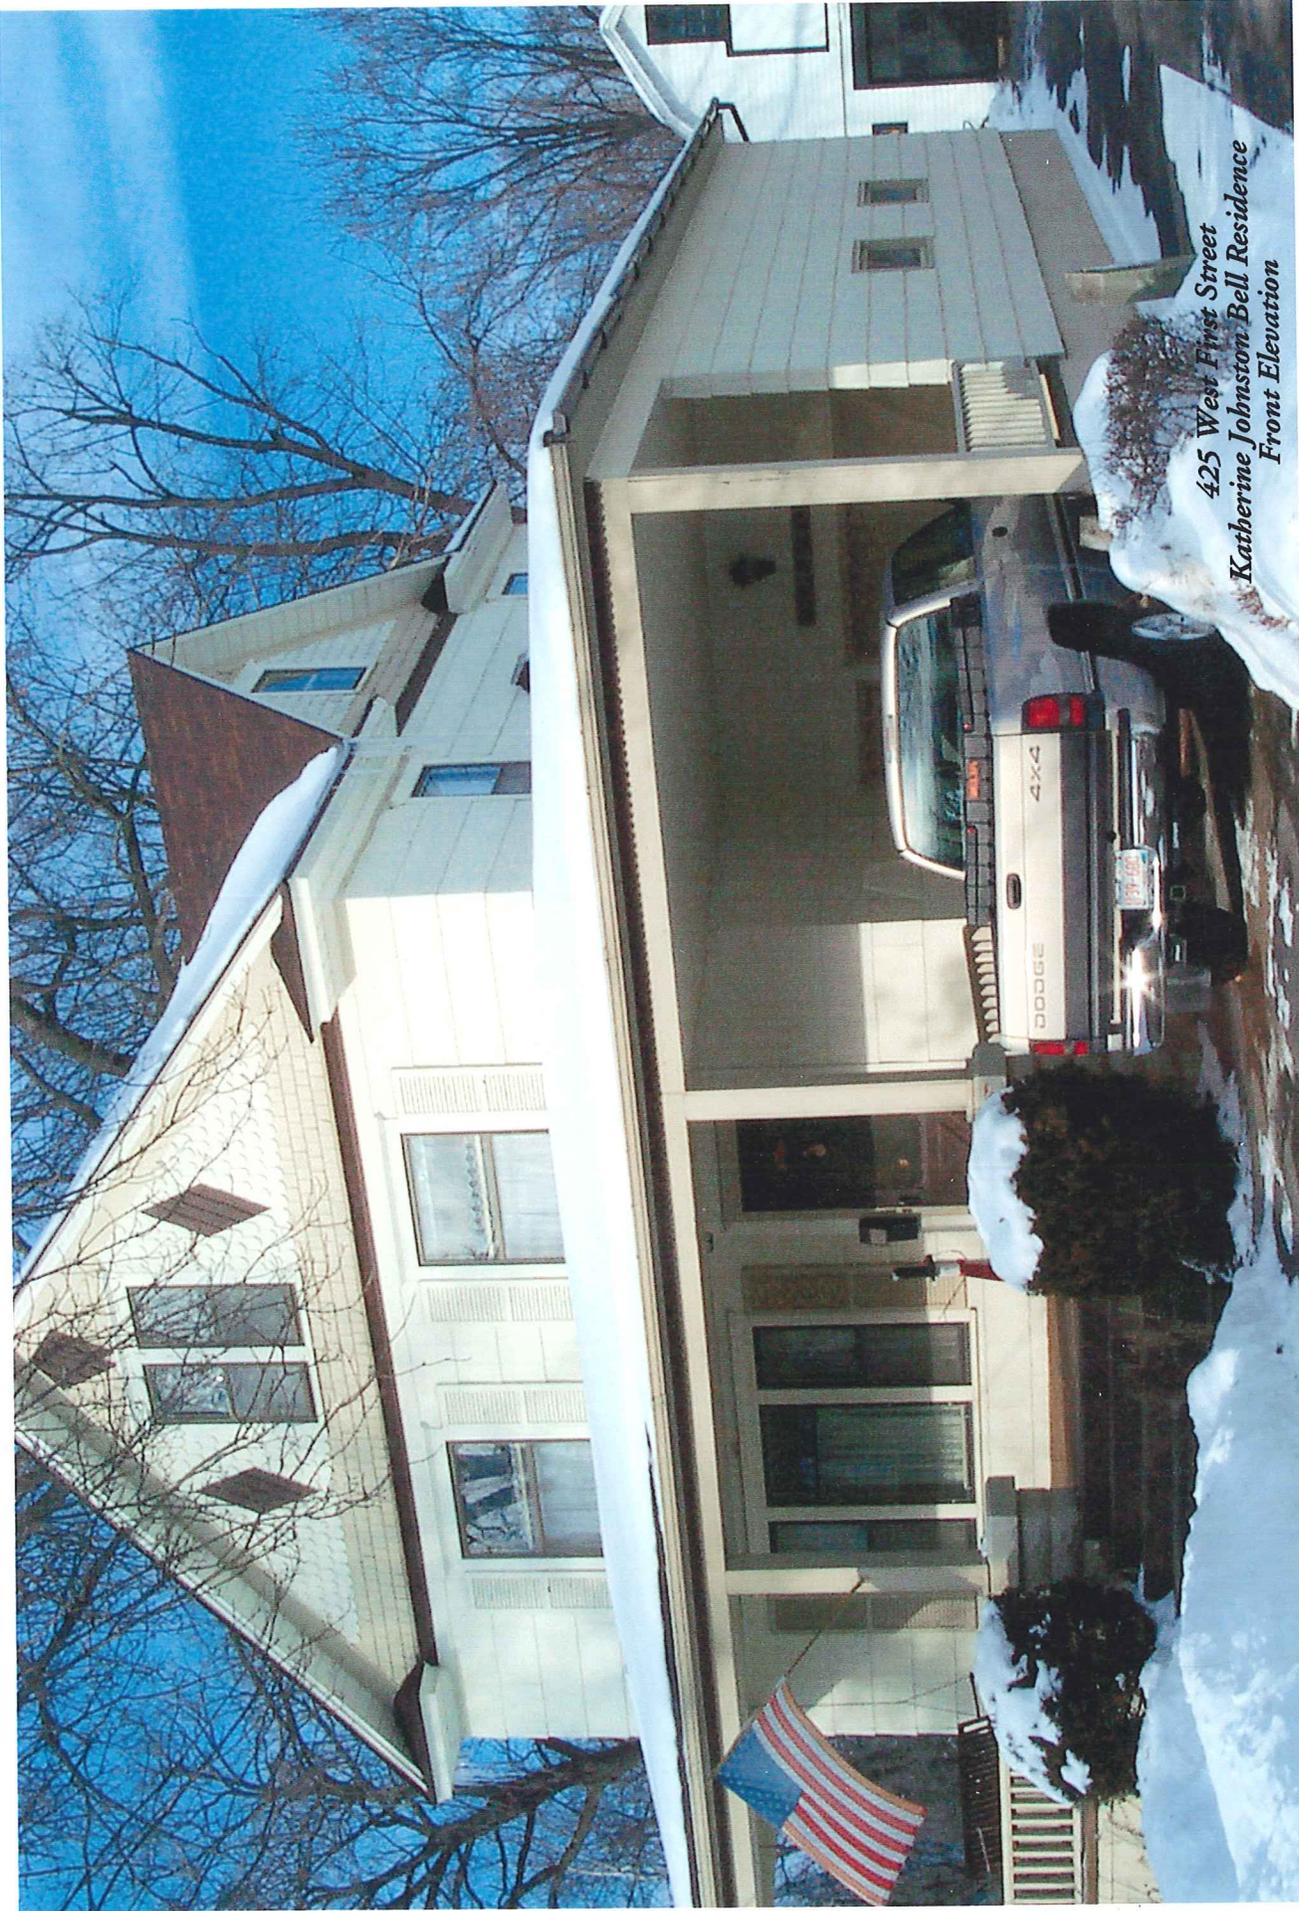
*425 West First Street  
Katherine Johnston Bell Residence  
Front Elevation*

Less than that, redetailing portions of the garage will make it fit better. The windows should be changed to double hung sash. The handrail placed in the opening of the wall is not used for its original purpose and hence looks out of place. A Victorian lattice enclosure of this opening would be fully appropriate and would serve to shield some of the garage and its attendant vehicles from view. In general parking of vehicles in front of the building set back line is inappropriate to maintaining the character of the street facade

Foundation planting along the east side of the garage will do a great deal to connect the garage to the ground.
